Inspection Report

Property Address:
3578 Kearney Ave
Memphis TN 38111

AmeriSpec MidSouth

Date: 12/5/2024	Time:	Report ID: 21182
Property: 3578 Kearney Ave Memphis TN 38111	Customer: Conor Driscoll	Real Estate Professional:

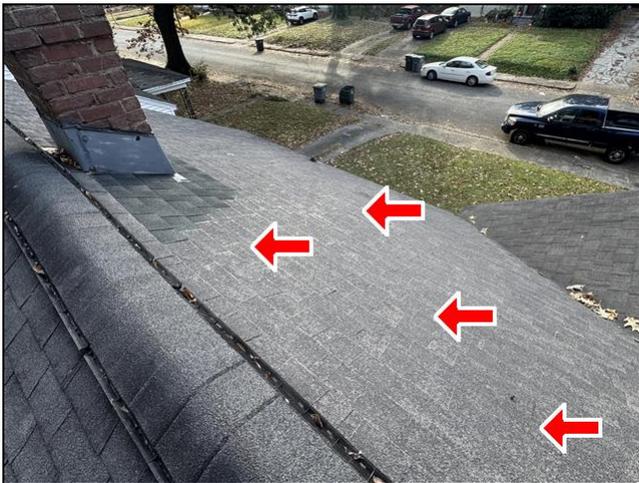
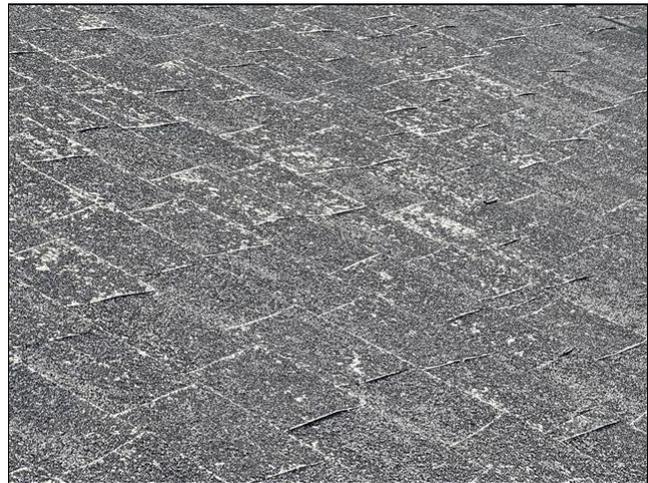
1.0 Item 1(Picture)

(1) Shingles at front of home showed heavy granular loss associated with age. Recommend roofing contractor review and replace as needed.

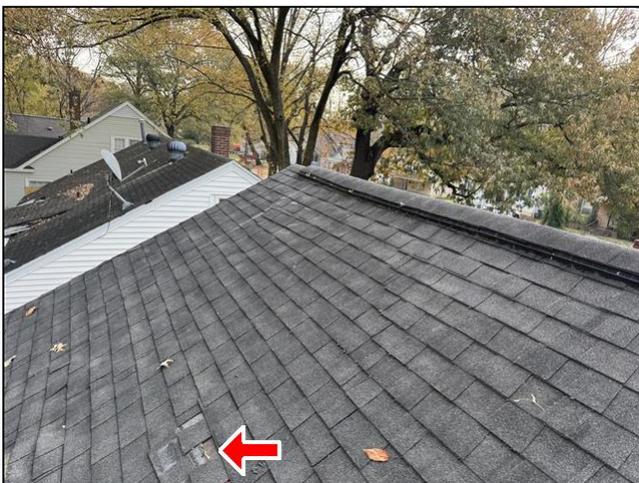
1.0 Item 3(Picture)

(2) Loose, misaligned and cracked shingles noted on roof in several locations. Recommend roofing contractor review entire roof and repair or replace as necessary.

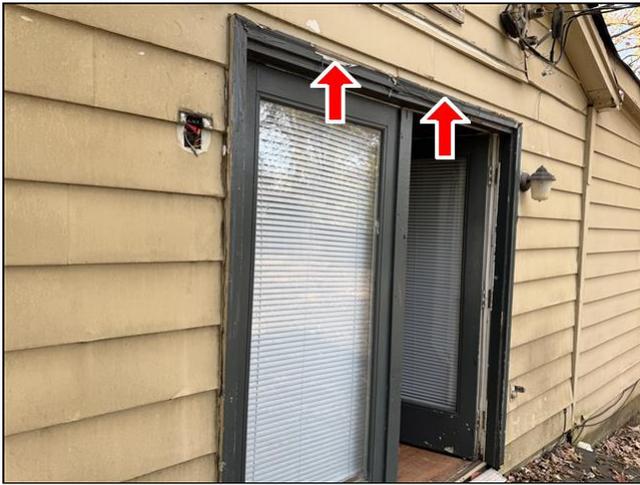
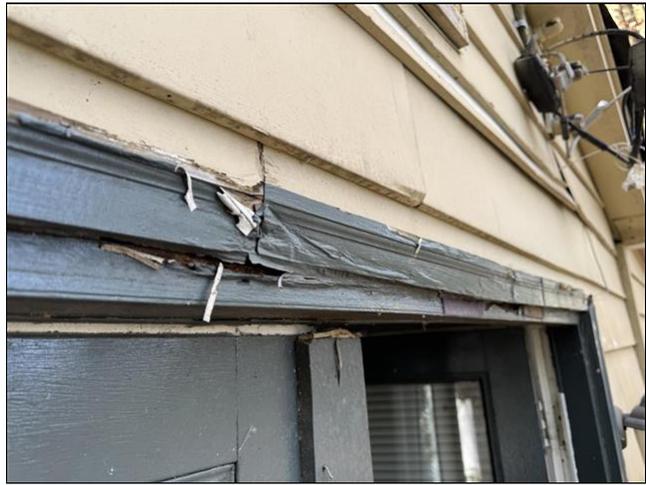
2.0 Item 1(Picture)

(1) Water damaged trim at back door. Recommend contractor replace all water damaged trim.

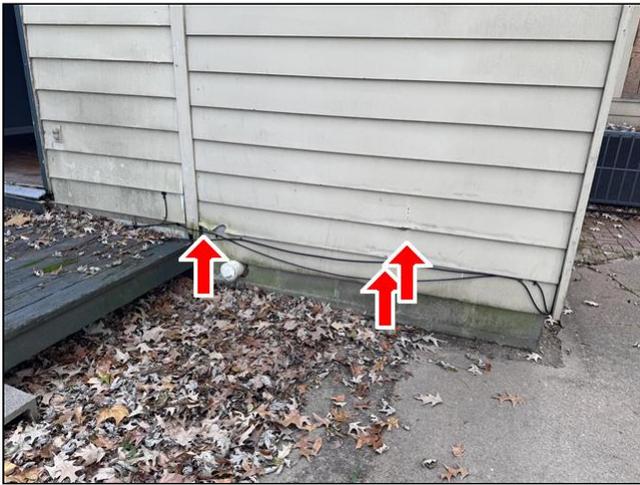
2.0 Item 3(Picture)

(2) Masonite siding at rear of home is water damaged in several areas. Recommend contractor review all siding and repair or replace as needed.

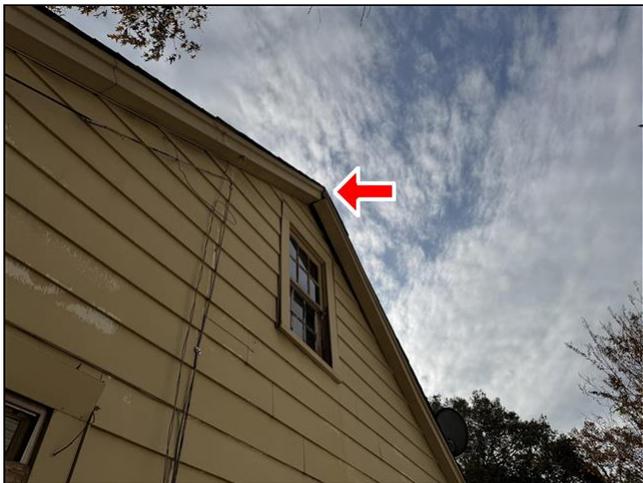
2.0 Item 7(Picture)

(3) Missing/damaged metal siding and trim noted in numerous locations. Recommend qualified contractor review all metal siding and trim and repair or replace as necessary.

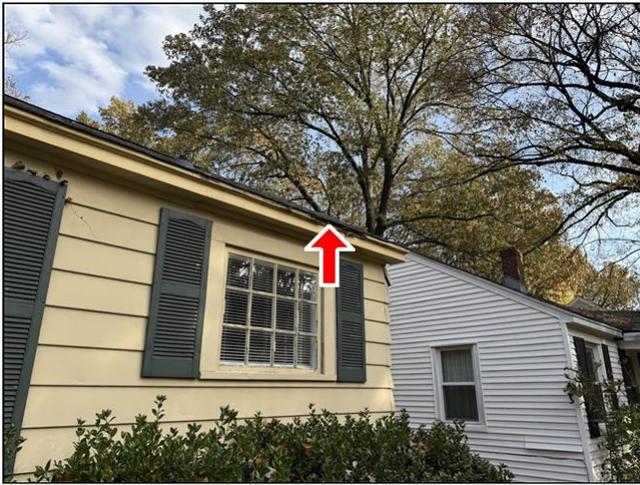
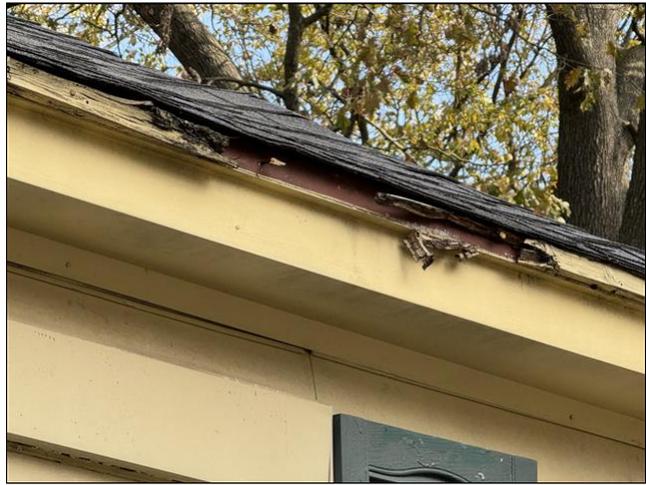
2.0 Item 19(Picture)

(4) Water damaged trim at front of home. Recommend contractor review and repair.

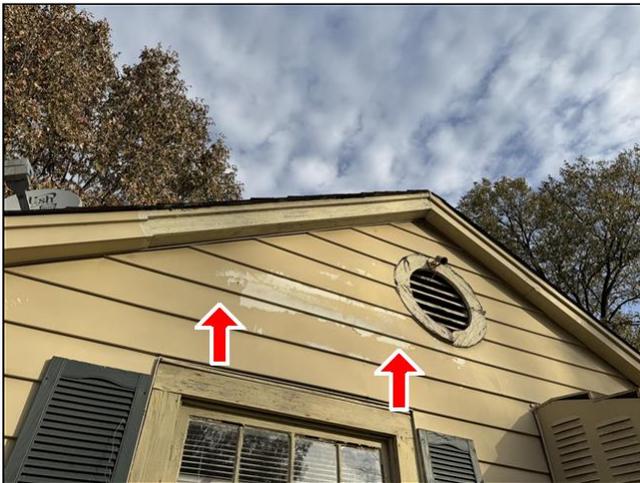
2.0 Item 21(Picture)

(5) Deteriorated paint noted on exterior siding in several locations. Recommend contractor repaint as needed.

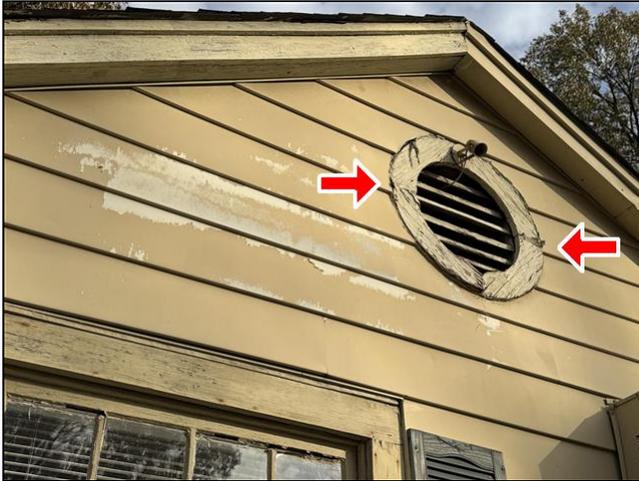
2.0 Item 25(Picture)

(6) n Peeling paint and damaged wood noted on gable vent trim at front of home. Recommend contractor review and repair or replace as necessary.

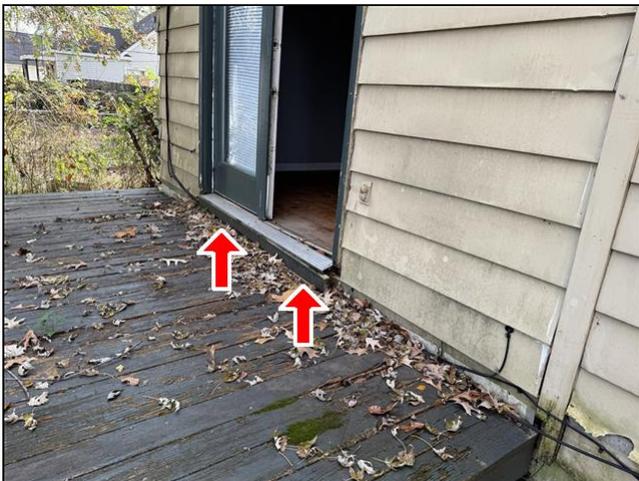
2.1 Item 1(Picture)

(1) Loose threshold and water damaged wood at rear door of home. Recommend contractor review and repair or replace as needed.

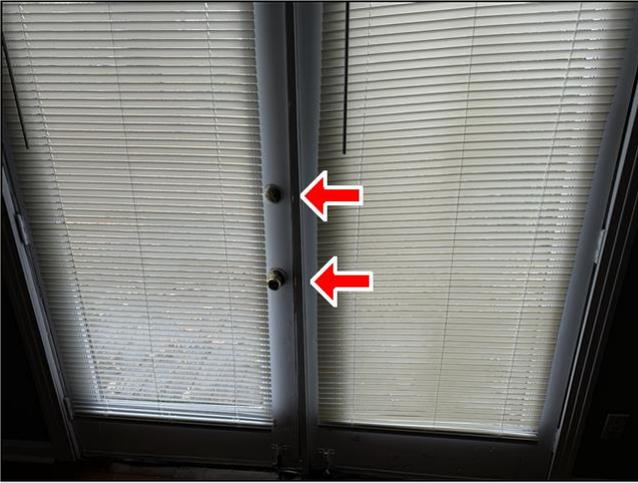
2.1 Item 3(Picture)

(2) Locks on back door not functioning. Recommend contractor replace locks to ensure proper operation.

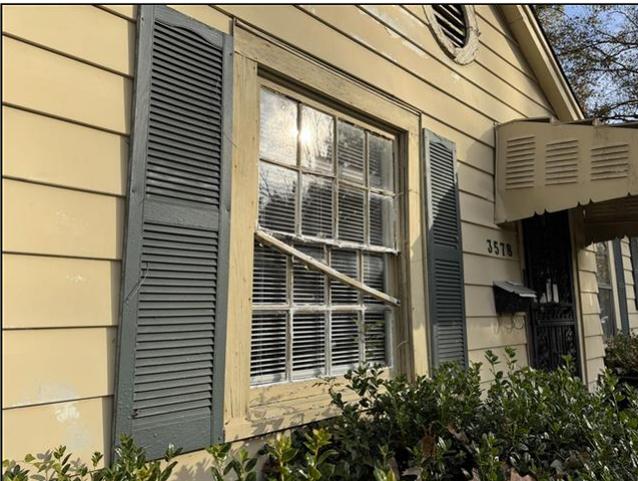
2.2 Item 1(Picture)

Windows at front of home have damaged wood and heavily damaged/deteriorated glazing. The remainder of the windows were boarded and could not be inspected. Recommend contractor review all windows and repair/reglaze or replace as necessary.

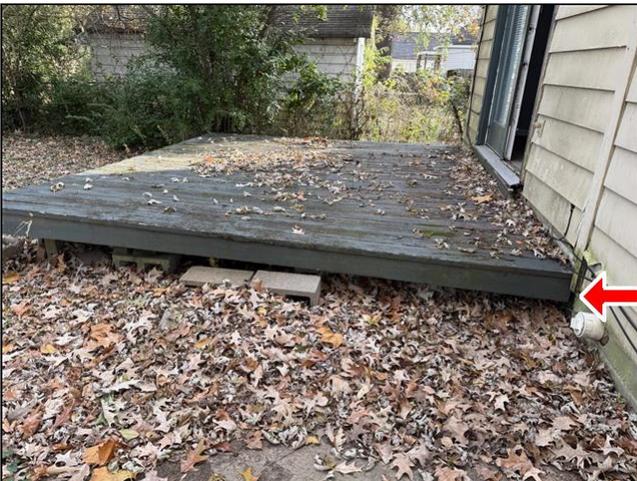
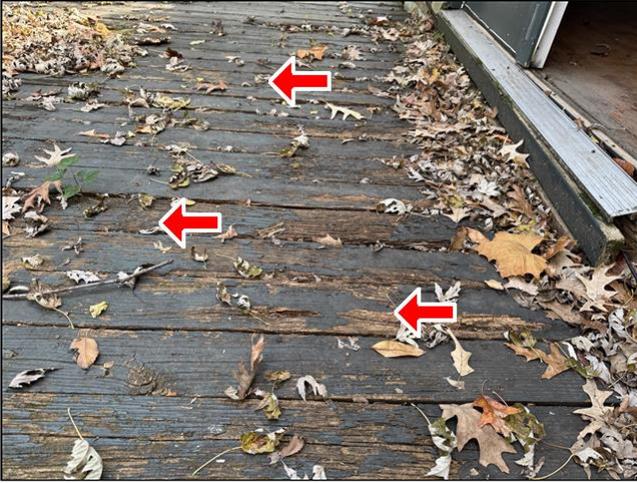
2.3 Item 1(Picture)

(1) Deck at rear of home is loose on footings and has water damaged deck boards. Deck likely needs to be removed/replaced in the inspectors opinion. Recommend qualified contractor review and repair or remove or replace as necessary.

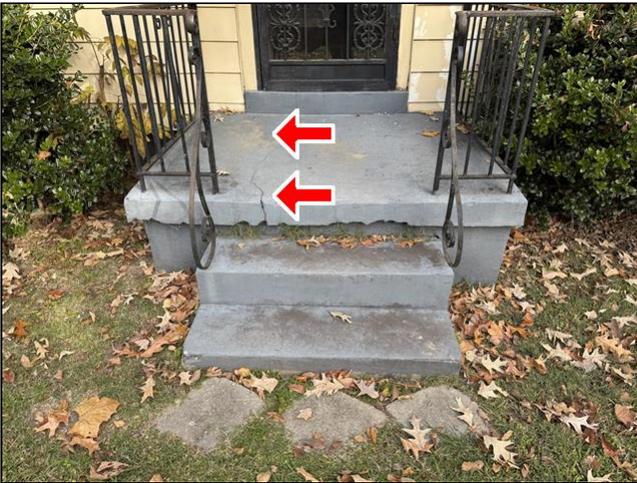
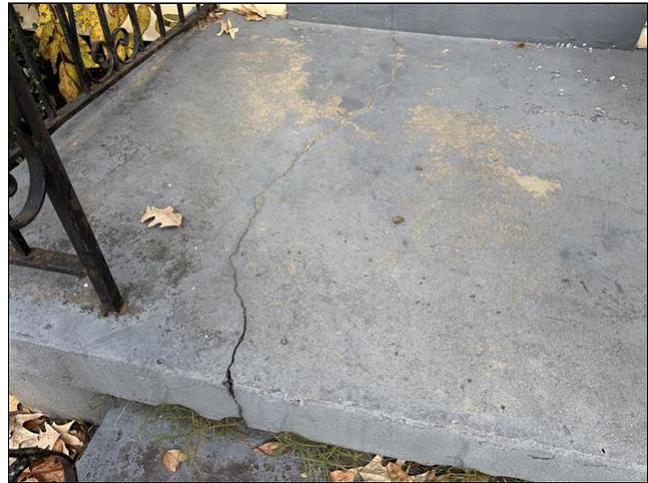
2.3 Item 4(Picture)

(2) Crack noted in concrete on front porch. Recommend sealing crack and repair if needed.

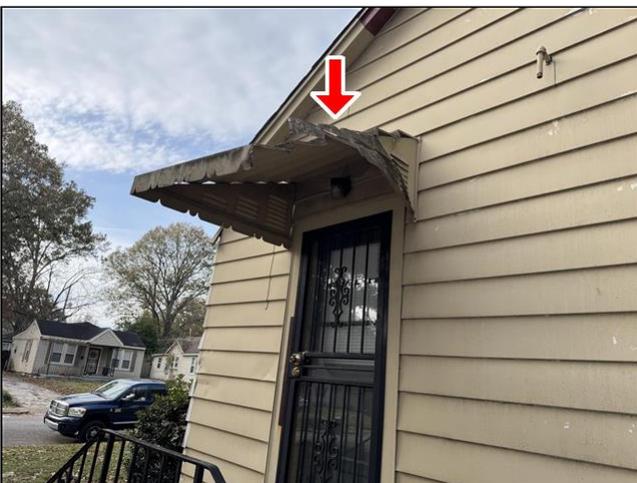
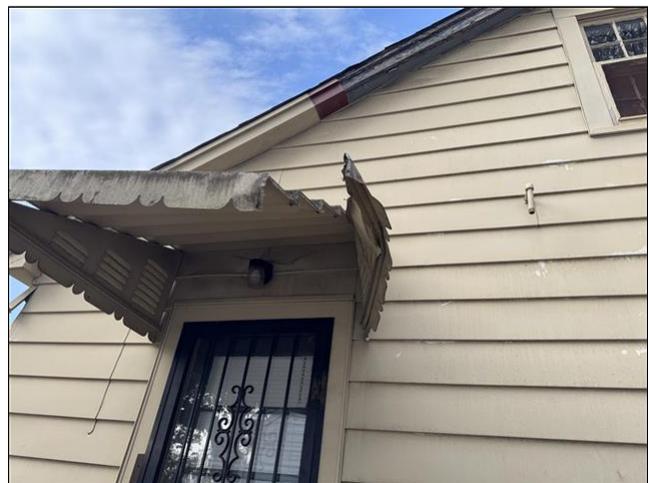
2.3 Item 6(Picture)

(3) Damaged awning at side door to kitchen. Recommend contractor review and repair or replace as needed.

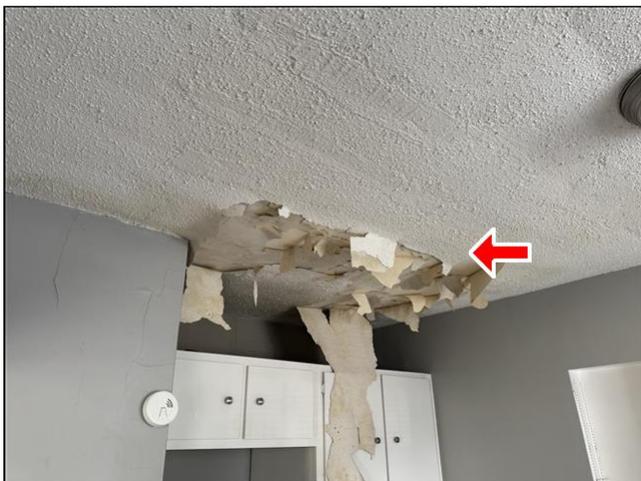
4.0 Item 1(Picture)

(1) Evidence of leak on ceiling in kitchen. Recommend roofing contractor review and repair. Also, recommend contractor repair ceiling and wall in this area.

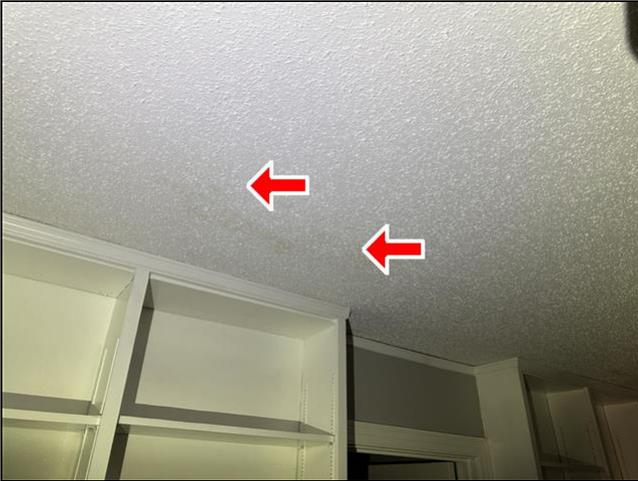
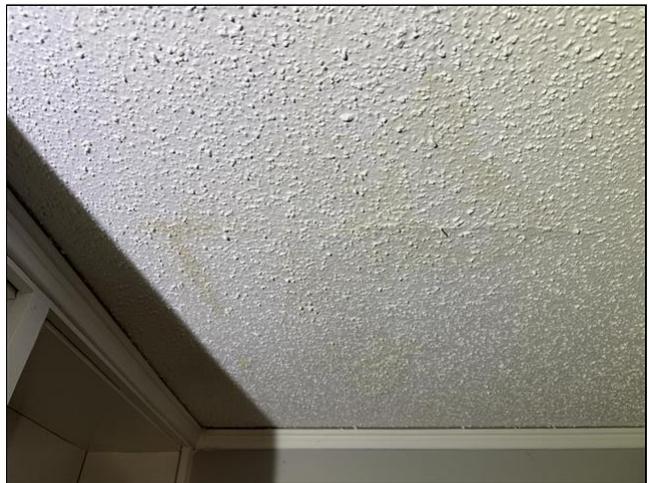
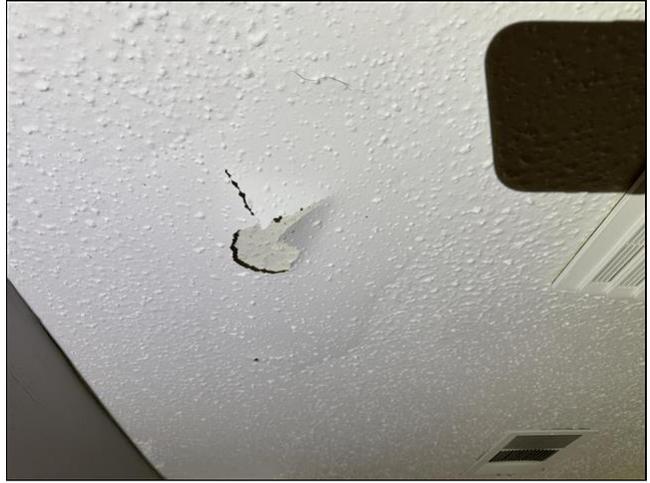
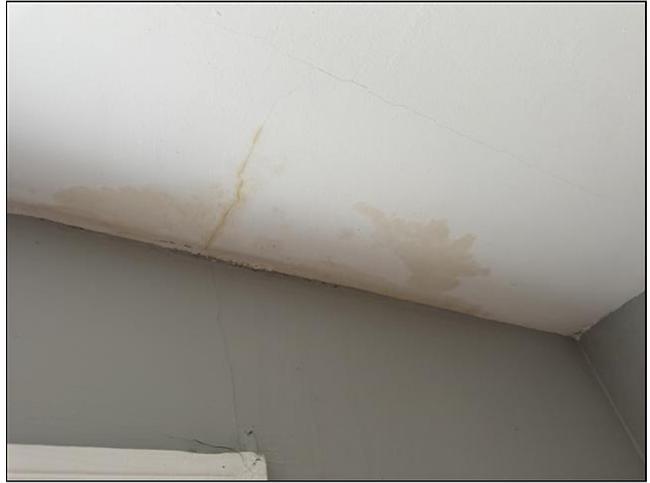
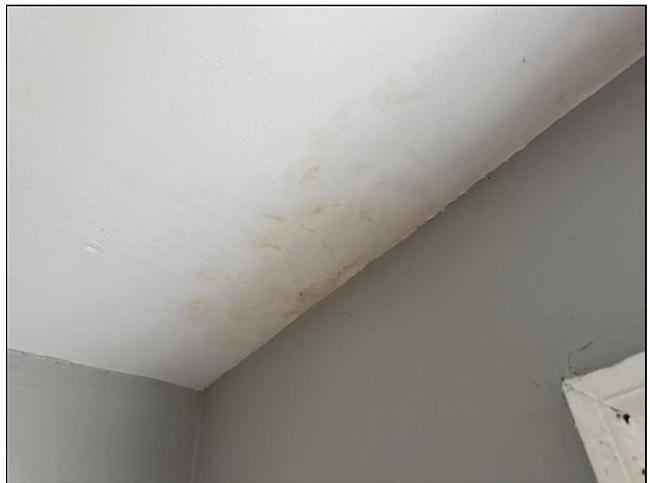
4.0 Item 4(Picture)

(2) Numerous water stains noted on ceilings throughout home. Recommend roofing contractor review roof and repair or replace. Additionally, recommend contactor repair and repaint all damaged areas of ceiling.

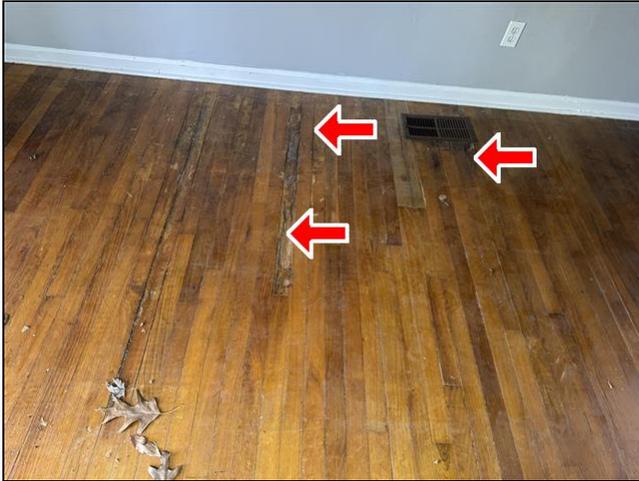
4.2 Item 4(Picture)

(2) Damaged/faded wood flooring noted in areas of home. Recommend flooring specialist review entire floor and repair or replace as needed.

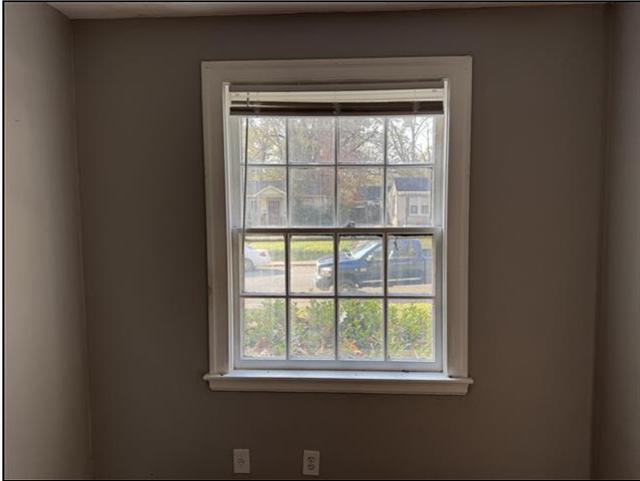
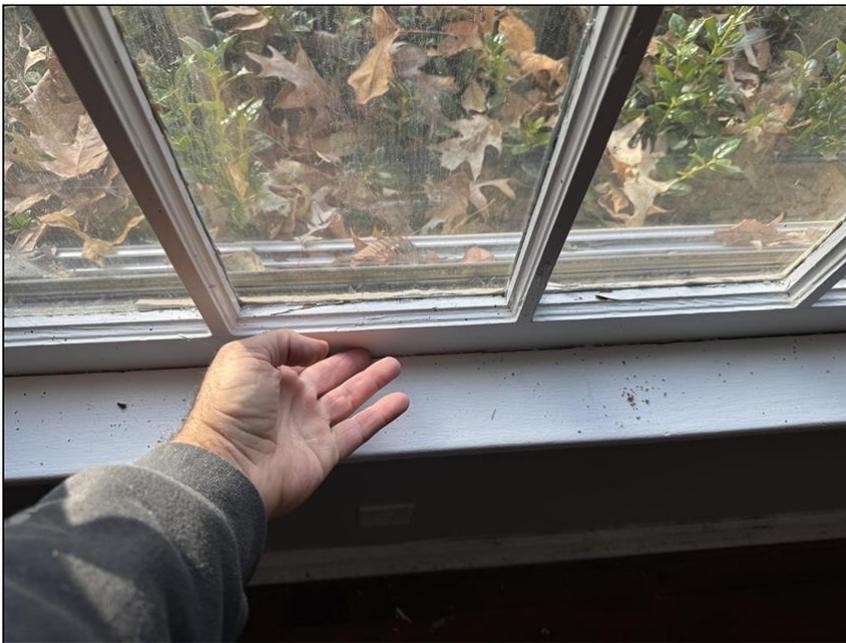
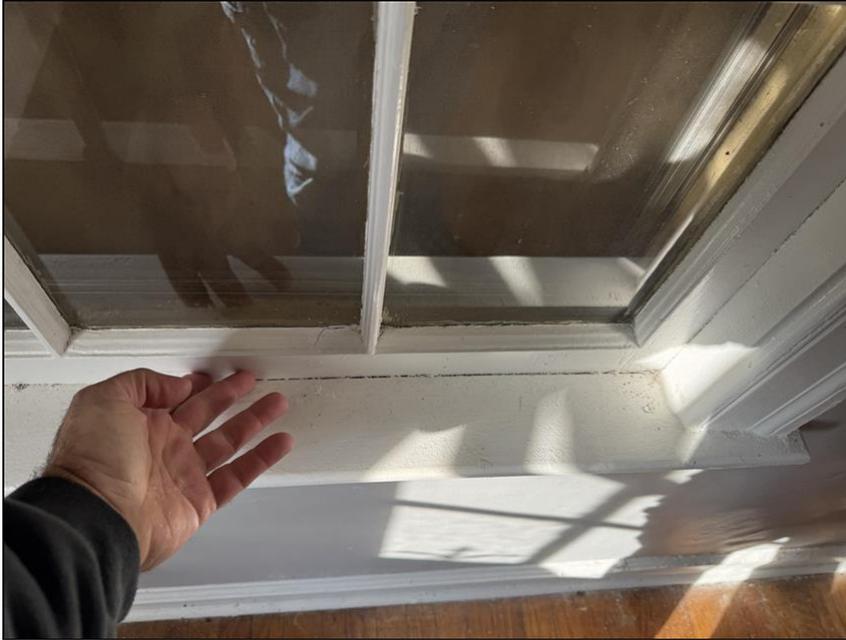
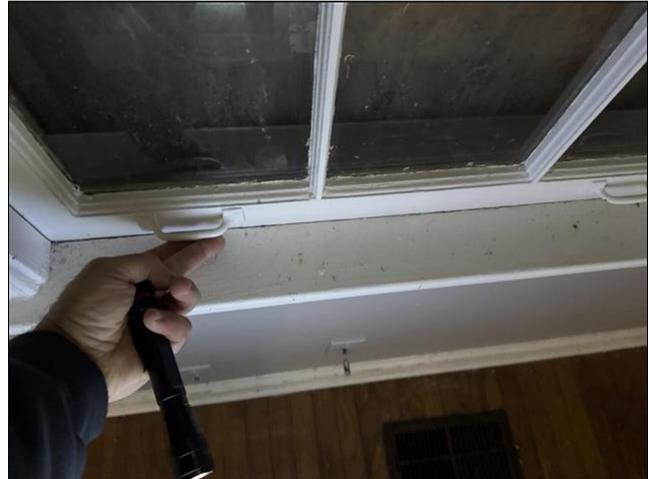
4.6 Item 1(Picture)

(1) Windows in the home do not open, likely due to being painted shut. Recommend contractor "free" windows to ensure proper operation and means of egress in case of emergency.

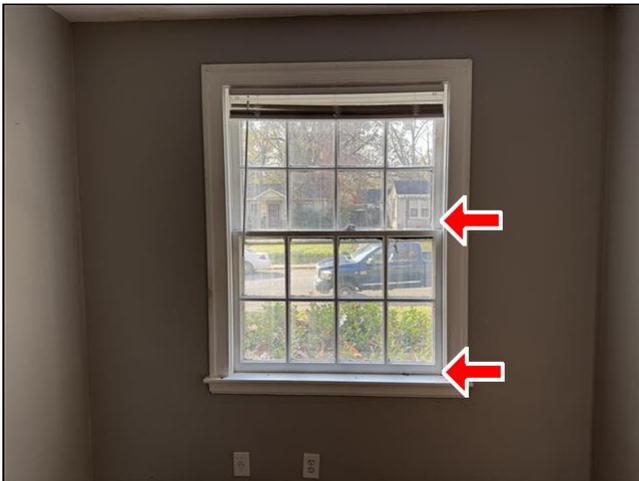
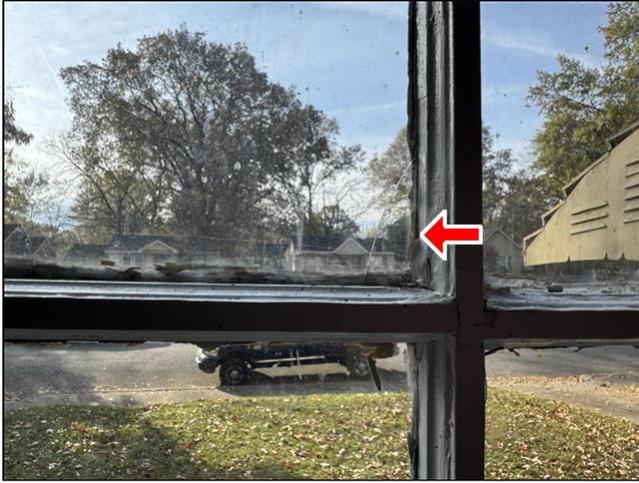
4.6 Item 7(Picture)

(2) Two cracked window panes at front of home. Recommend contractor replace broken window panes.

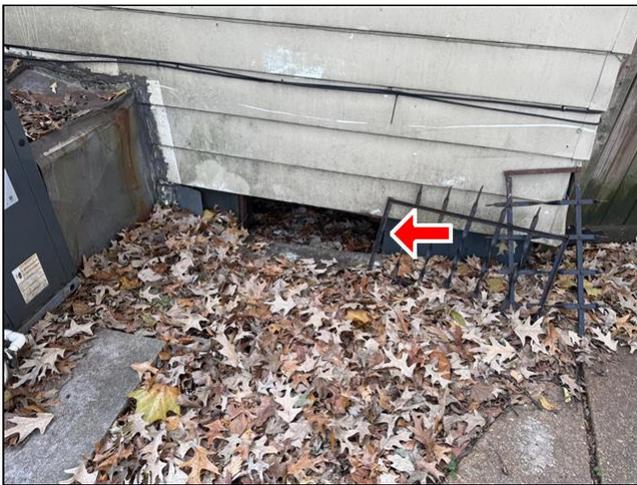
5.0 Item 1(Picture)

Crawlspace was only viewed from opening due to restricted access.

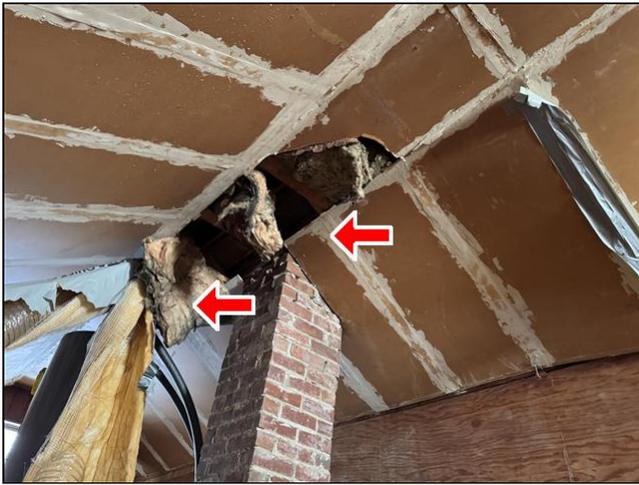
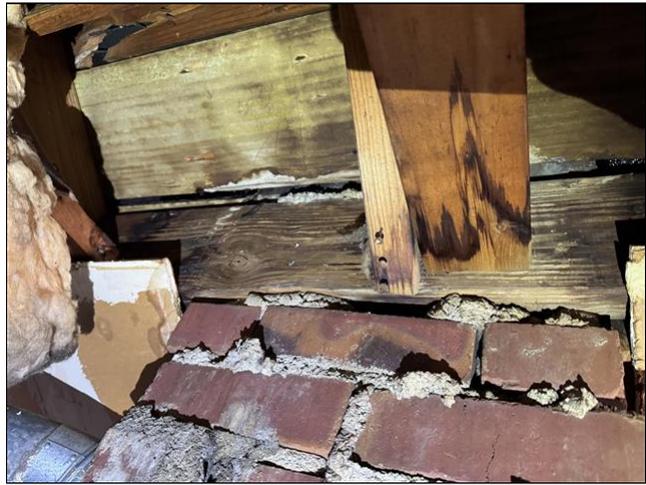
5.5 Item 1(Picture)

Evidence of leak in attic near chimney. Recommend roofing contractor review and repair as needed.

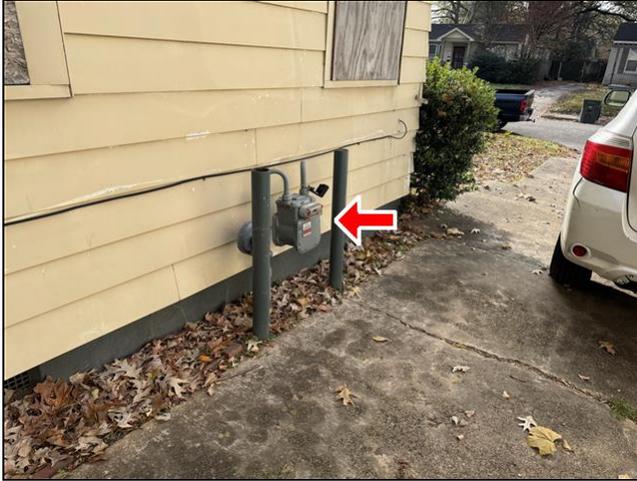
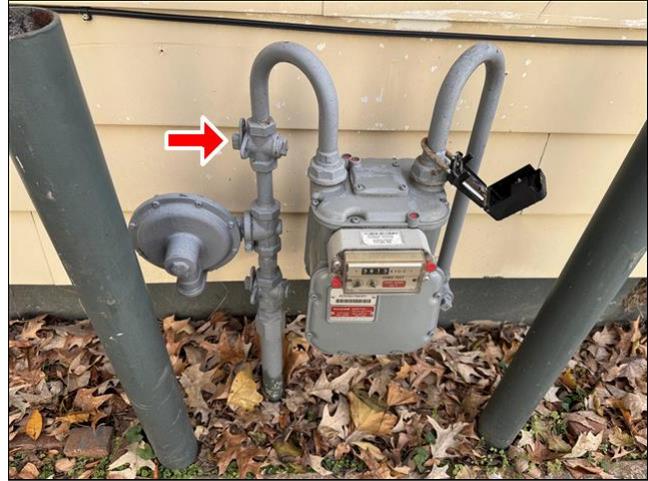
6.5 Item 1(Picture)

Main fuel shut-off is located on gas meter at side of home. This is noted for client information.

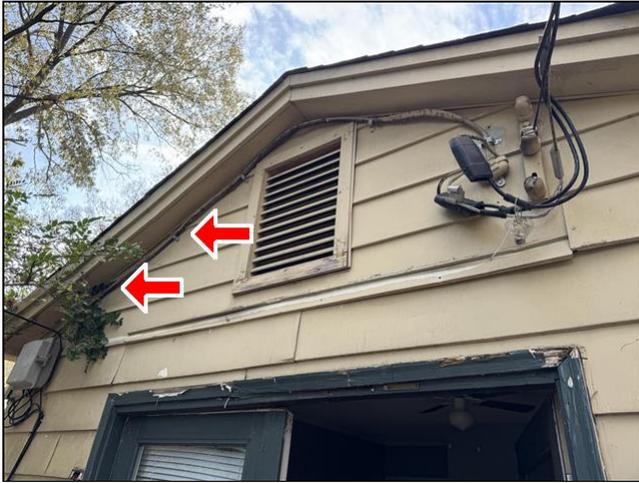
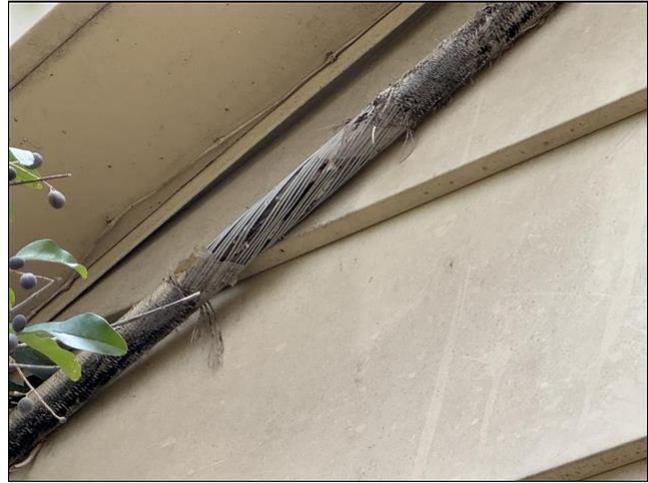
7.1 Item 1(Picture)

(1) Frayed/missing coating on main service wire at rear of home. Recommend licensed electrician review and repair or replace as needed as this is a safety hazard.

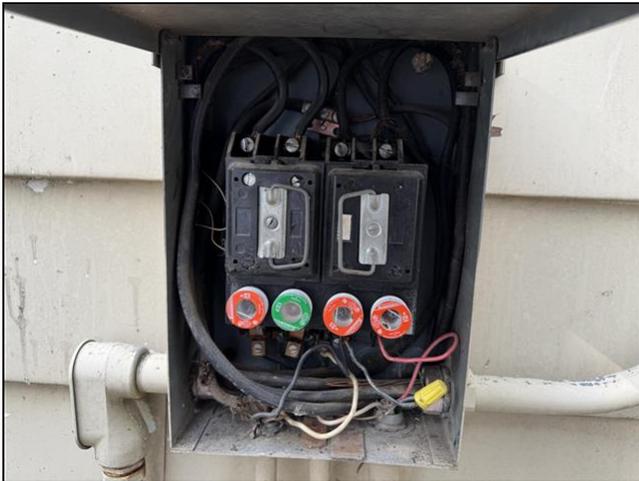
7.1 Item 3(Picture)

(2) Electrical panels are split into sub-panels and two are older fuse-style boxes. Recommend review by a licensed electrician. Client may consider upgrading to one, larger breaker box.

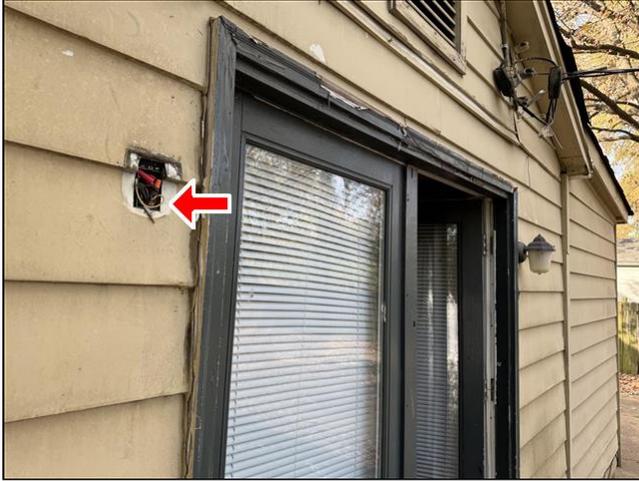
7.7 Item 1(Picture)

Open electrical connection at rear of home. Recommend qualified contractor review and cover or install proper exterior fixture.

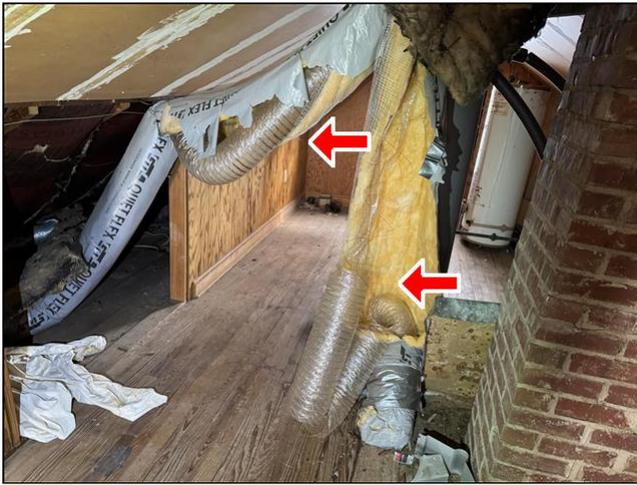
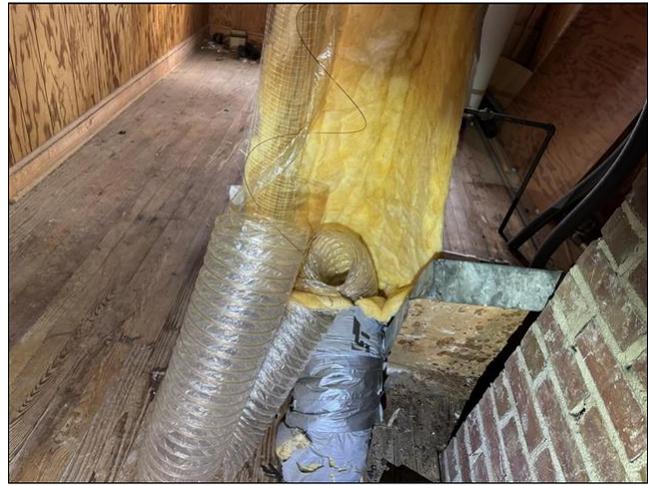
8.3 Item 1(Picture)

(1) Damaged air duct in attic. Recommend replacing to ensure proper operation.

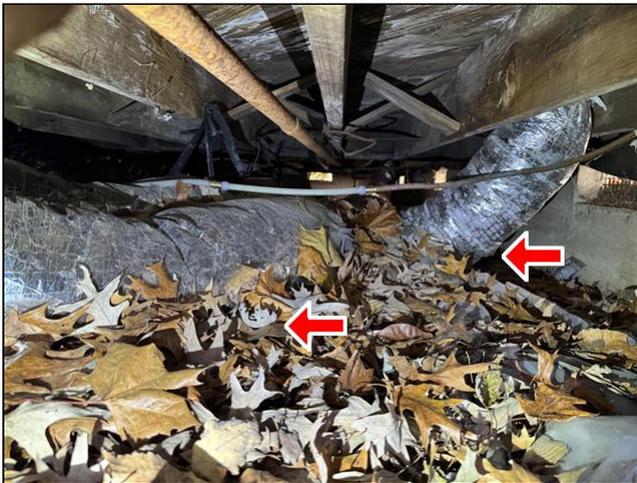
8.3 Item 3(Picture)

(2) HVAC ducts laying on ground in crawlspace. Recommend HVAC specialist review and hang ductwork if needed.

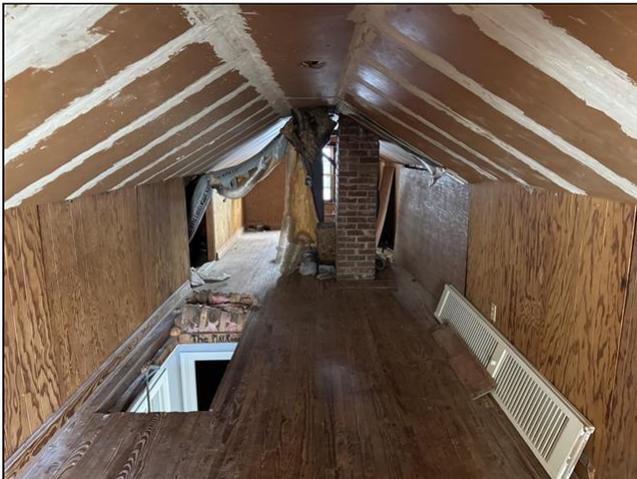
9.0 Item 1(Picture)

Attic space was partially built out with walls and ceiling. During this process, insulation was installed between roof rafters directly below roof decking. To be done properly, baffling which creates an air channel should have been installed. Recommend removing walls, ceiling and insulation between rafters in attic in order to restore attic to proper condition.
